Journal of Forensic Research and Criminal Investigation

Fire Investigation in an Industrial Grade Nitrocellulose Plant

An incident of fire was reported in an industrial grade nitrocellulose manufacturing unit. Forensic investigation was carried out to find the cause of fire. The scene of fire was thoroughly examined and searched for the evidence. Partially burnt samples of debris and burnt electrical wires were collected from the scene of fire. The GC-MS analysis of the debris revealed the presence of hydrocarbons belonging to fire accelerants. A study of CCTV footages revealed the origin and time of fire. Basing on the findings and the information gathered during field visit, it was opined that the incident of fire was caused due to human intervention.

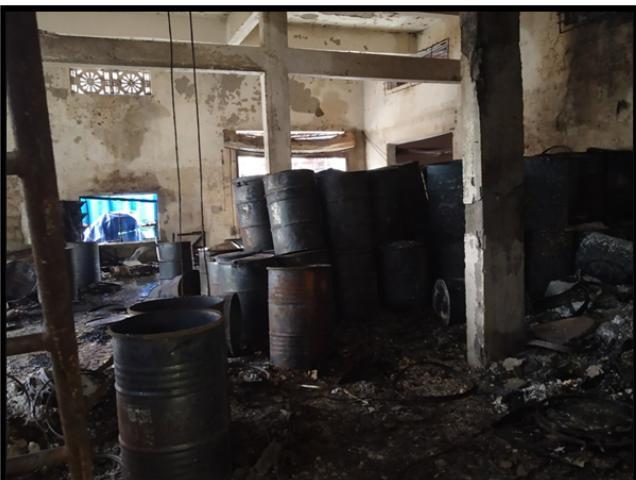
addition to raw material (wet nitrocellulose). All the material stored in the storage area was found to be partially burnt (Figure 3).

Figure 3. Different Sizes of the Drums.

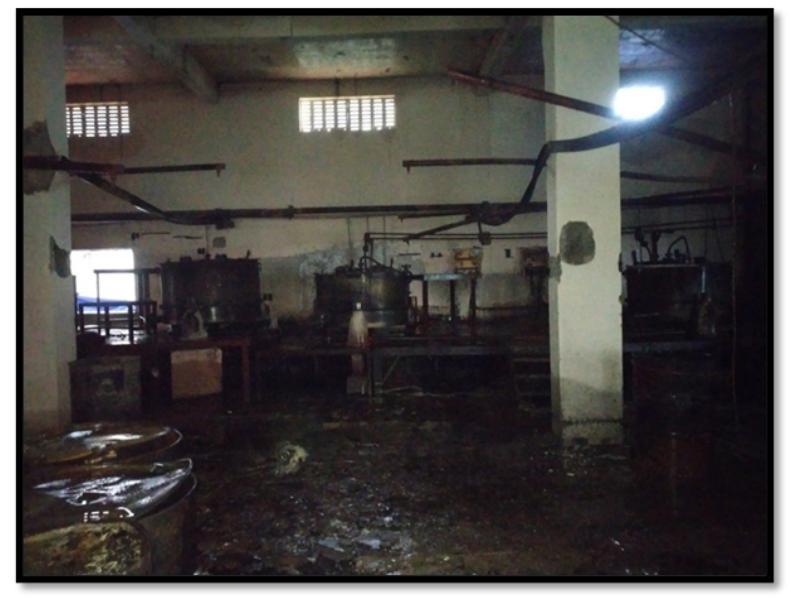
The manufacturing area contained three centrifuges (Figure 4) on the southeastern side adjacent to the wall which were superficially affected by fire. 200 drums kept in the manufacturing area were found to be partially burnt.

Figure 4. Centrifuges in the Manufacturing area.

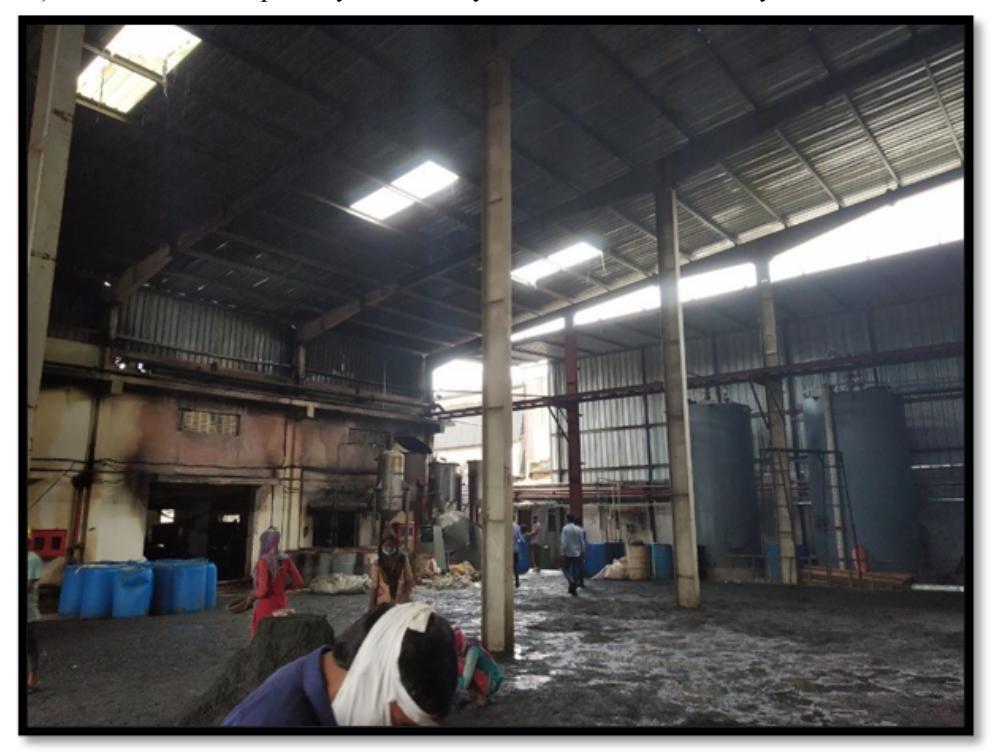
The finished product storage area (Figure 5) (adjoining the fire. The solvent tanks in the finished product storage area manufacturing area) was found to be partially affected by

were found to be totally intact and were not affected by fire.

Figure 5. Finished products storage area.

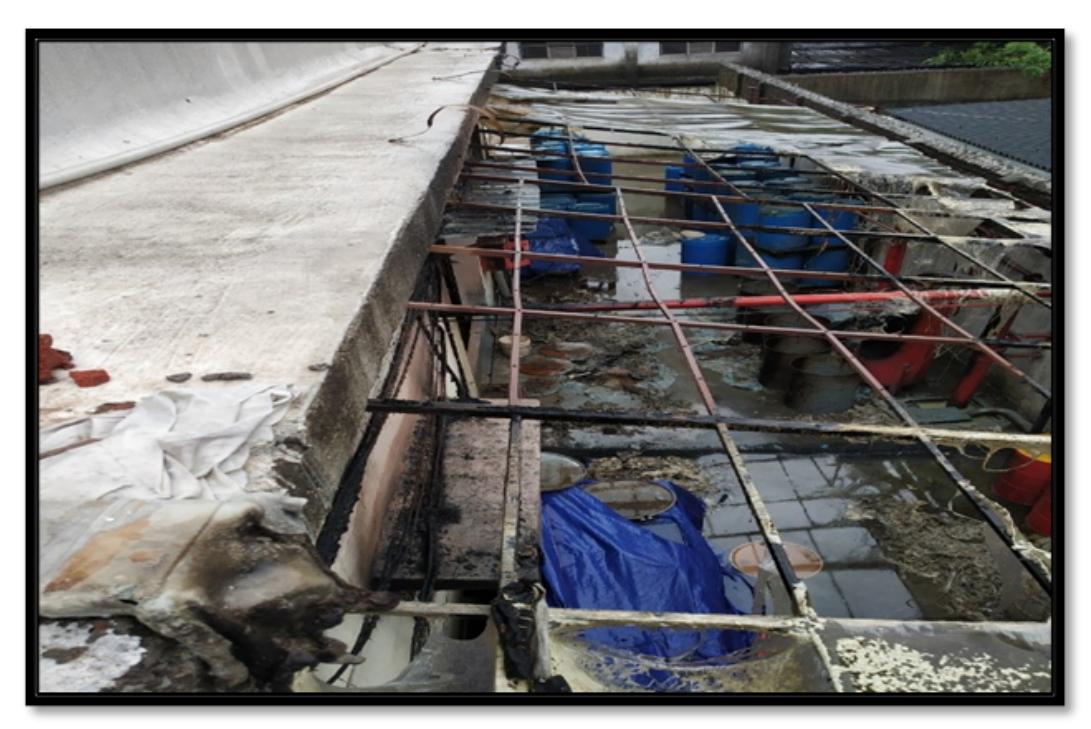
The working shed located behind the building of the manufacturing and raw material storage area was found to be superficially affected by fire. Even though the roof was

burnt, the drums and panel boards located there were not affected by fire (Figure 6).

Figure 6. Working Shed.

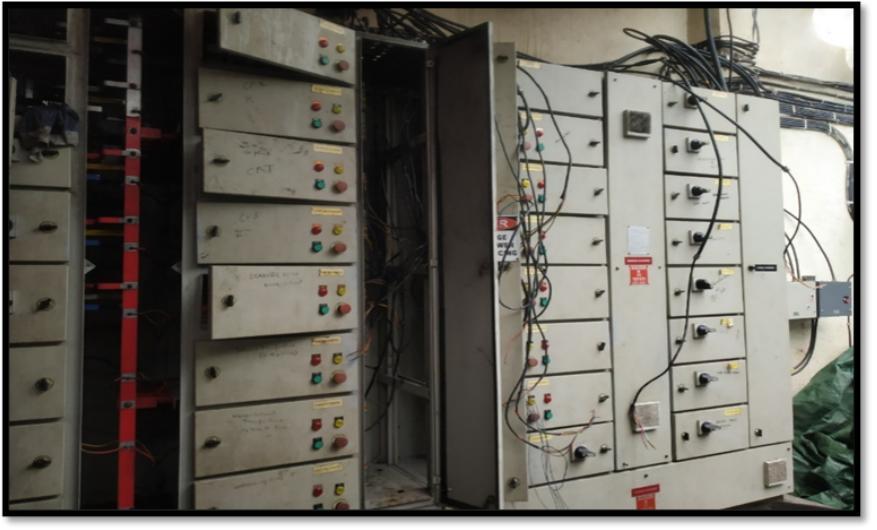
The electrical panel located in the working shed was not affected by fire (Figure 7).

Figure 7. Electrical Panel Board.

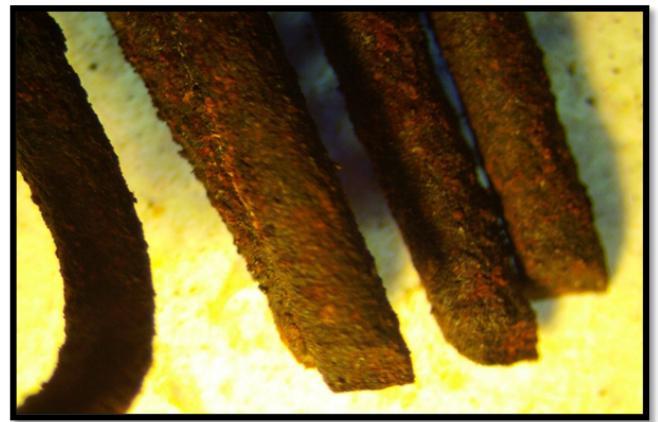
The stereomicroscopic examination of the burnt wires did not show any symptoms of short circuit such as Beading (one of the images is shown in (**Figure 8**).

Figure 8. Stereomicroscopic Results.

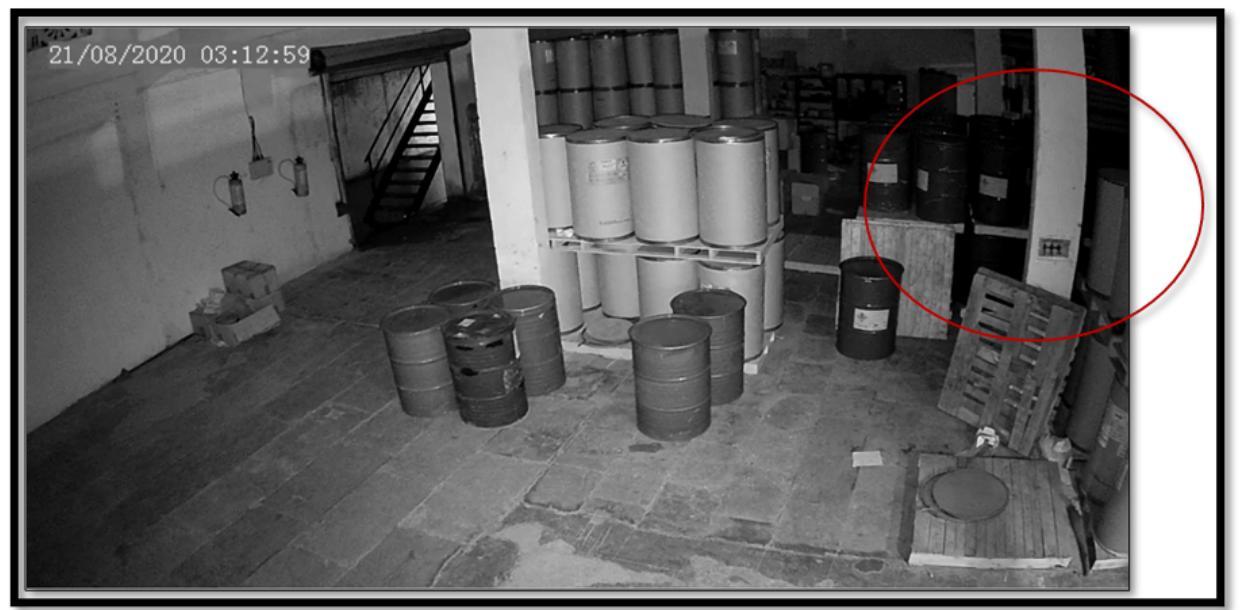
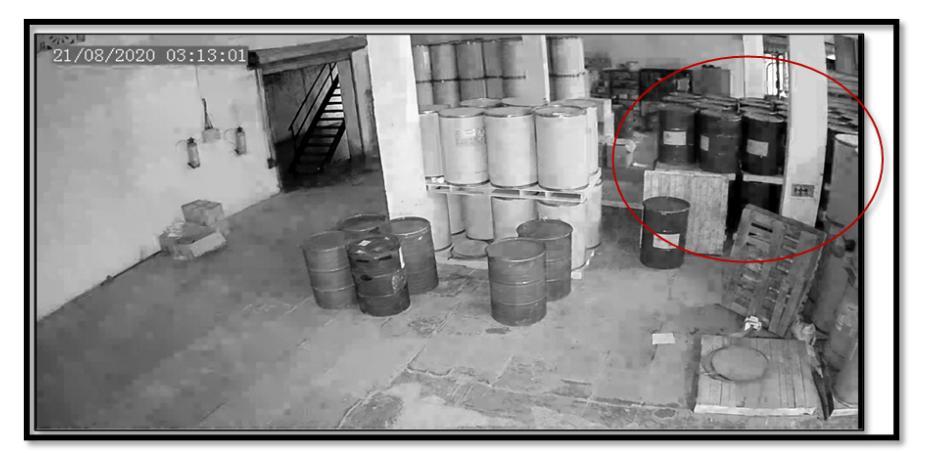
The CCTV footages of Cam 2 fixed above the door between passage in the office to the raw material storage area showed a flash of light at 03:13:01 in the manufacturing area. The snapshot before the flash **Figure 9** and after the flash **Figure 10** is shown below.

Figure 9. Before the blast flash (marked in red).

Figure 10. After the blast flash (marked in red).

The CCTV footages of Cam 6 located near the water tank in the compound wall besides the working area (and behind the raw material storage area) also showed a flash of light at 03:13:01. From the above, it is concluded that the fire originated at 03:13:01 with a burst of flame in the manufacturing area. This could happen only due to sudden ignition of solvents Isopropyl Alcohol, Butanol and nitrocellulose that were used in the manufacturing process. These substances even though flammable require external ignition to catch fire. At the time of fire incident, there was no manufacturing activity in the factory and no high-power drawing machinery/equipment was being used. The transformer and its circuitry were found to be in normal working order and no symptoms of short circuit were noticed in the electrical wires collected in and around the switch board of the manufacturing area such as beading and hence fire due to short circuit or any other electrical related causes was ruled out. As the plant was closed, fire caused due to friction due to some worker inadvertently dragging the drums on the concrete floor was also ruled out. As there was tight security, the workers/employees bringing cigarette/ match boxes into the premises and consequent fire due to negligence was ruled out. The results of GC-MS analysis of the fire debris samples collected at four out of five locations in the plant showed the presence of hydrocarbons belonging to fire accelerants such as diesel/kerosene. As these hydrocarbons cannot be found in the combustion products of the solvents used for manufacturing purposes, their presence in the debris collected indicates an external ingress of diesel/kerosene. Further, the detection of hydrocarbons at four different locations inside the factory also indicates multiple origins of fire. However, these could not be captured in the CCTV footages as no camera was focused on these areas.
