Journal of Forensic Research and Criminal Investigation

Fire Investigation in an Industrial Grade Nitrocellulose Plant

An incident of fire was reported in an industrial grade nitrocellulose manufacturing unit. Forensic investigation was carried out to find the cause of fire. The scene of fire was thoroughly examined and searched for the evidence. Partially burnt samples of debris and burnt electrical wires were collected from the scene of fire. The GC-MS analysis of the debris revealed the presence of hydrocarbons belonging to fire accelerants. A study of CCTV footages revealed the origin and time of fire. Basing on the findings and the information gathered during field visit, it was opined that the incident of fire was caused due to human intervention.

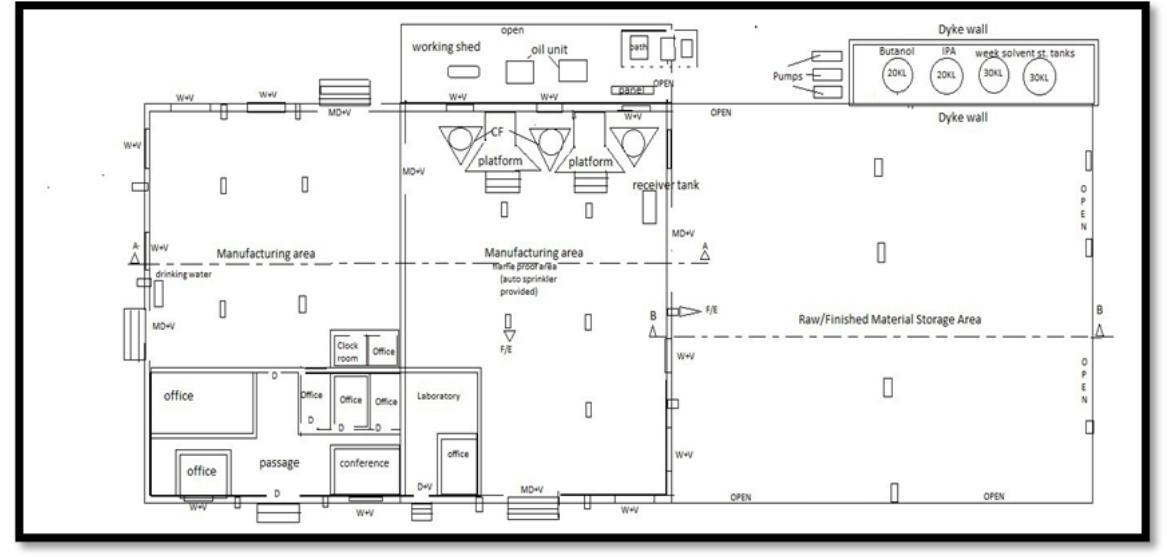
Figure 2. Layout of the factory.

meant for raw material storage area and the adjacent hall (15mx22m) called manufacturing area where three centrifuges were arranged adjacent to the southeastern wall. Behind the manufacturing area of the RCC building and the southeastern compound wall, working shed (15.5mx4m), with GI sheets roofing was located and contained one air compressor unit, two oil units & electrical panel board. Dyke wall of height 0.60 m was present behind the southwestern area where four tanks (one for Butanol 20 KL, one for I.P.A. 20KL and two solvent storage tanks each of capacity 30KL) were located. On the southwestern side of the manufacturing area finished material storage area (22mx25m) with GI Sheeted roof was located as shown in **Figure 2** below.
